Japan International Cooperation Agency

« Cooperation Program with Mauritius »

Mauritius, 29th October 2012

Capacity Development for Coastal Protection and Rehabilitation Outline of the Project

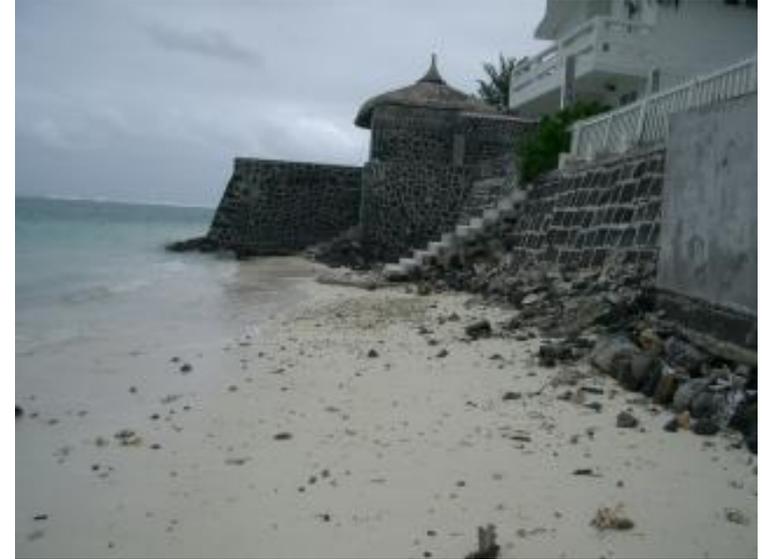
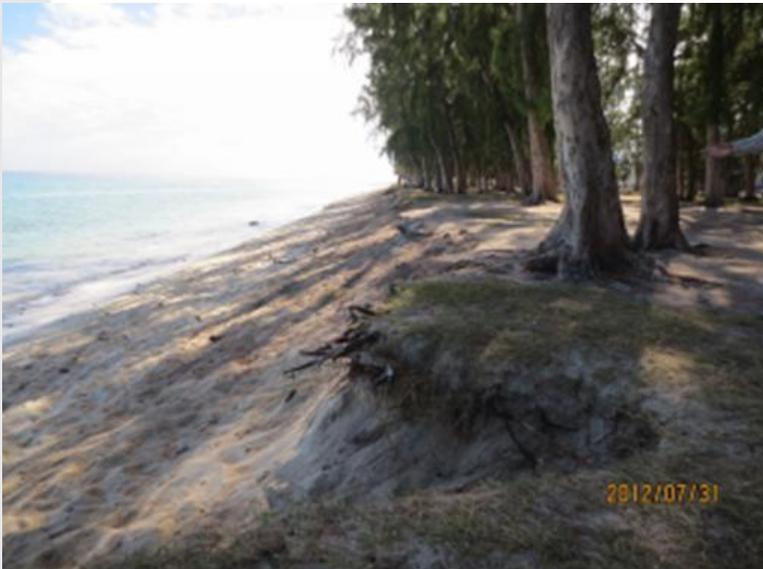
Long Term Erosion

30km long coastline was eroded from 1967 to 2008 in Mauritius. The maximum beach retreat was 20m.

At Pte. D'Esny 12m of erosion at an average (right)
