## Chapter 5

### SITE DESCRIPTION

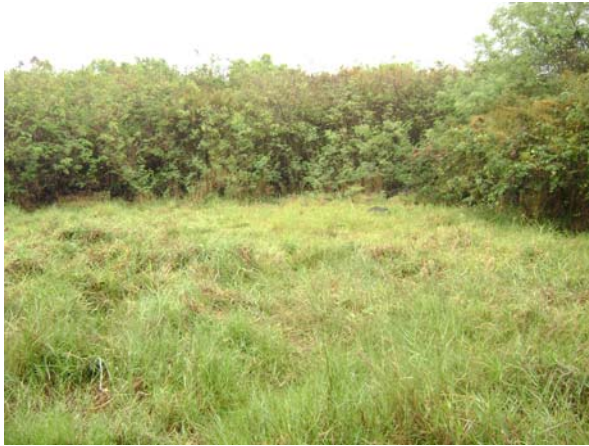
General view of wetland looking North

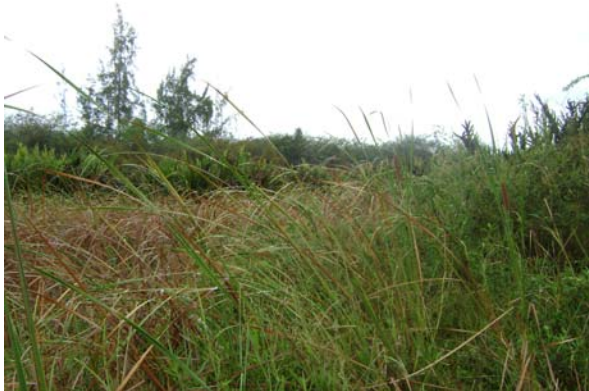
Cattails and chiendent
